**SAS Superstructure**

Location: 04-SF-80-13.2 / 13.9

Daily Diary Report by Bid Item

Diary #: 815 Const Calendar Day: 302 Date: 02-Apr-2013 Tuesday

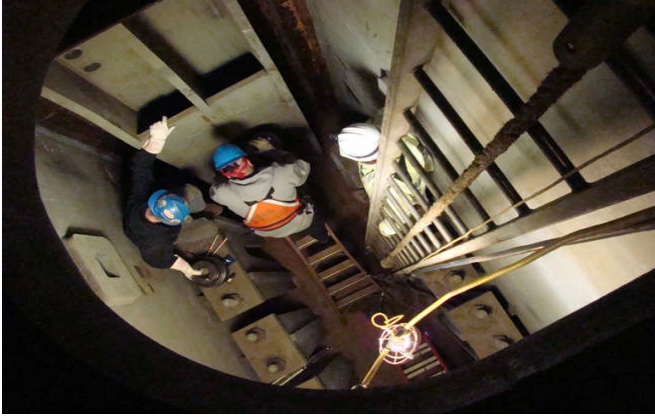
ABF ironworkers mobilizing jacks on anchor rods in a diaphragm seen from the first tower access platform.

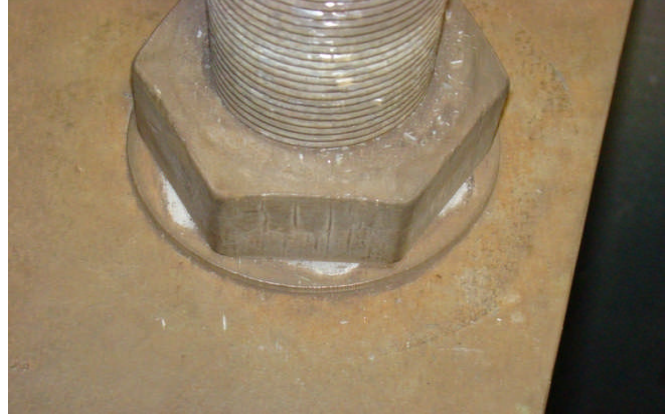
Stressing operations began today promptly at 7:00am in the North diaphragm. Other locations where anchor rod force verification was done included the South diaphragm, and the Inner East/West diaphragms. As in previous days all 3" anchor rods were stressed to 105% of Pjack. The majority of the nuts were found to be loose today and three stressing cycles were run to Pjack at 13.2ksi.

The amount that the typical anchor rod nut was turned today after tightening under a Pjack pressure of 13.2ksi multiple times.
